**Report Date** 4/16/2009

**Company** ConservEnergy Diagnostics

**Thermographer** Rick Blair, Lvl. I Certified Thermographer (Cert.# 7735)

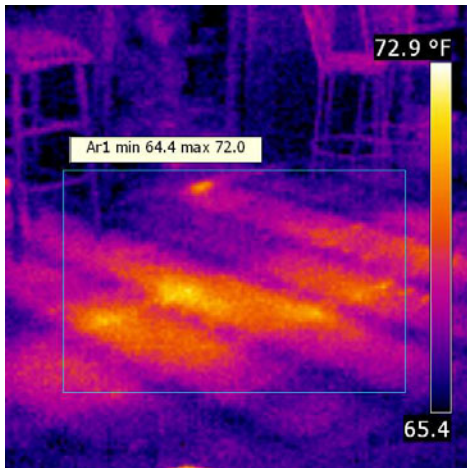
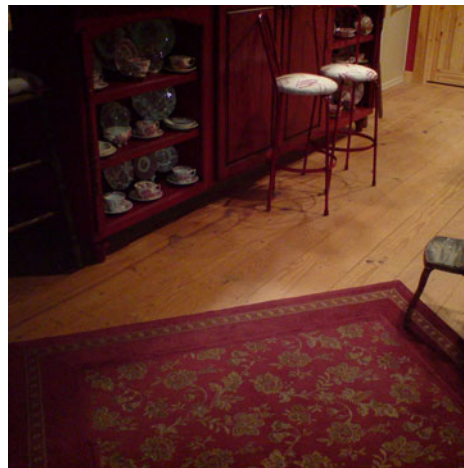
The largest of the apparent duct problems within the floor trusses. Visible light photo shows area just outside of kitchen.

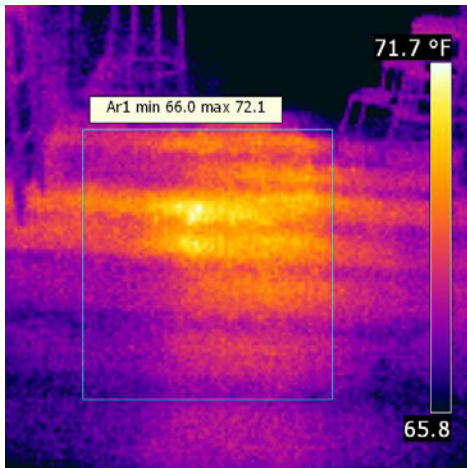
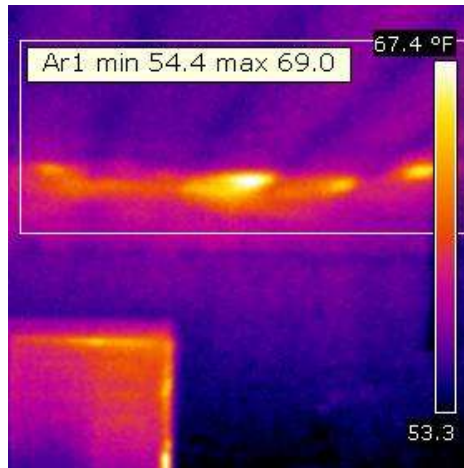
**Same problem area from another angle.**

**This IR pic shows the same problem area from below, looking up through the sheetrock in the library. (The doorway in lower left is the door leading to the HVAC closet in what was the old kitchen area)**

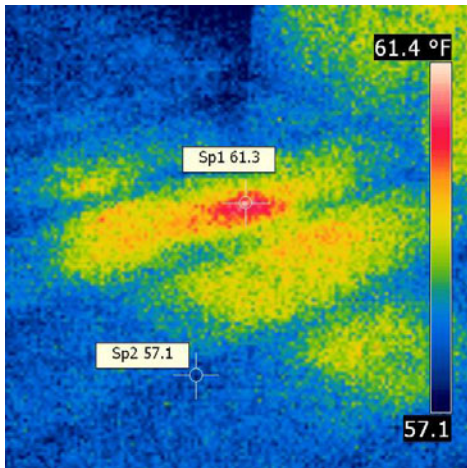
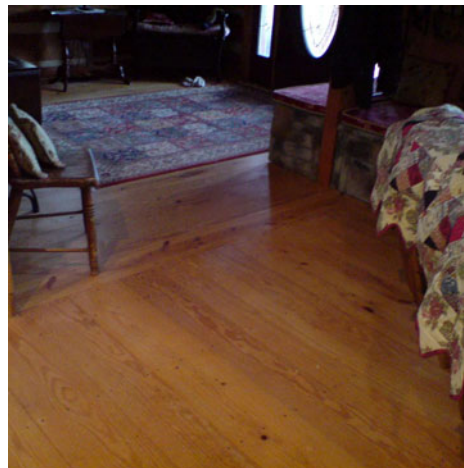
**This is the only other significant thermal anomaly in the truss system. Visible light pic on right shows area toward our front door.**

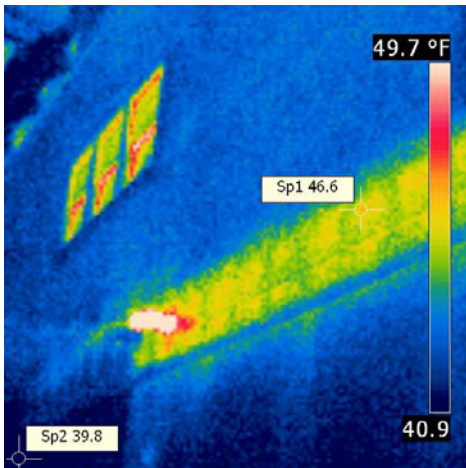
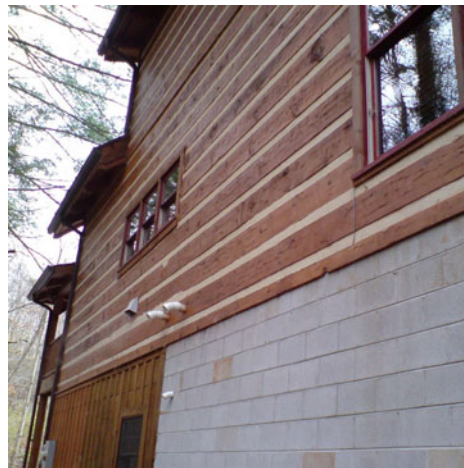
**IR pic shows where the truss band on rear of house is not insulated. Insulation stops around the right end of the triple kitchen window, just to the left of the vents.**
